TO READ CAREFULLY

SKYWATCH eole

SKYWATCH meteos

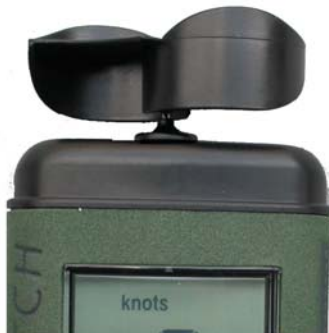
✓ **correct**

In one of our series of SKYWATCH eole and meteos, the shaft (little black cylinder that hold the axis) has a tendency to go out of its housing.

Left : the shaft is in its housing, the instrument works well.

Resolution of the problem : just push on the shaft to place it back in its housing. Be careful, push directly on the shaft and not on the impeller or on the axis (it may cause irreversible damages).

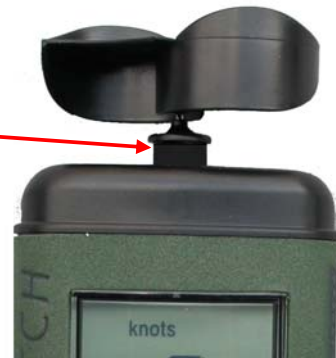
✗ **wrong**

Consequence : the shaft may raise when the cap is not correctly opened. If the shaft has risen, no data is transmitted by the impeller to the electronic anymore.

Right : the shaft is out of its housing, the instrument does not display any value even when the impeller is turning.

risen shaft

To replace the impeller, carefully pry up the entire shaft using a thin blade and gently pull up on the entire shaft assembly. Slide the new one into place, making sure it is seated all the way down.
